Our ref: DJH305-R01

PROJECT NO. DJH305: MODDERASRIVIER

LETTER REPORT ON THE PROPOSED ENLARGEMENT OF MODDERAS DAM

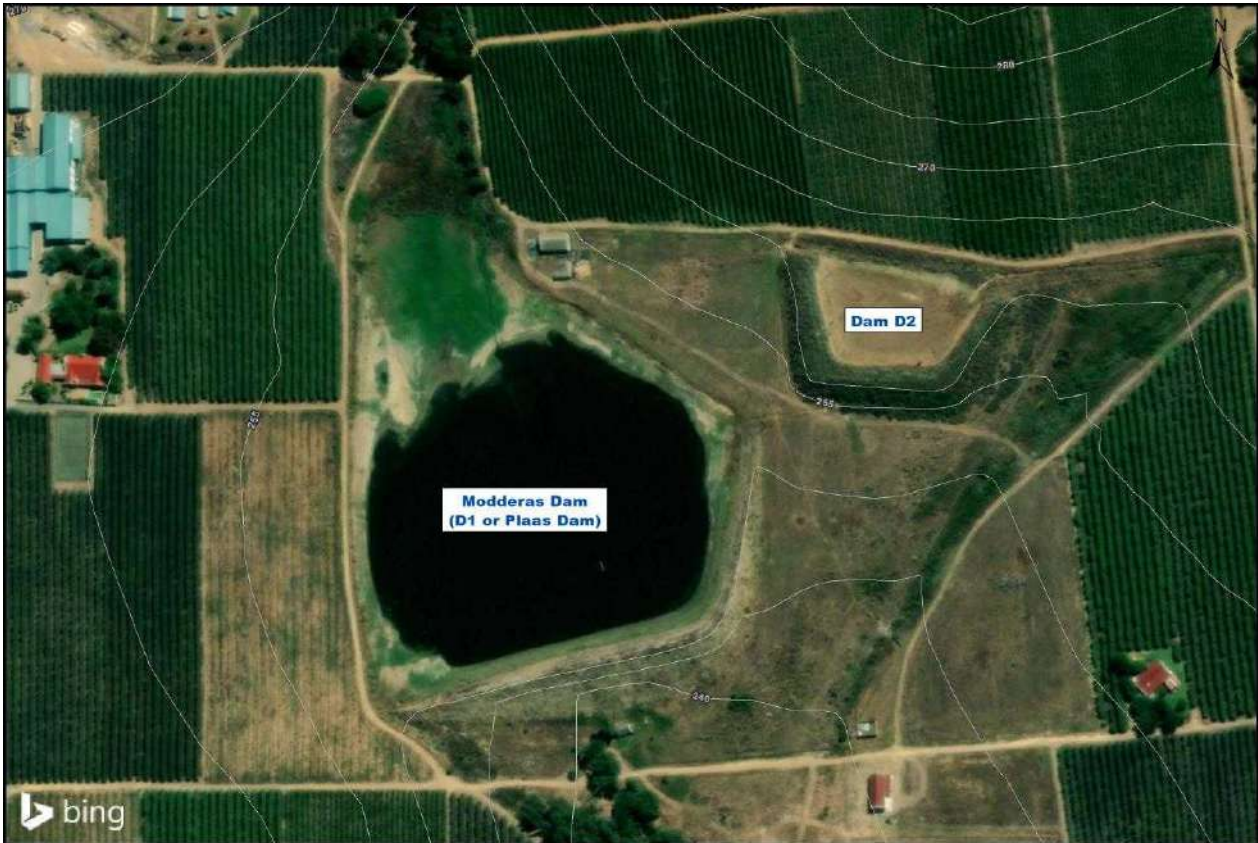
Figure 2-1: Existing dams on Farm 1/66

On Portion 1 of the Roode Zands Kloof Farm No. 66, there are two existing small dams: Modderas Dam (also known as D1 or Plaas Dam) and Dam D2. The dams' storage capacities are presented in **Table 2-2**.

The existing dams on the farm can be seen in **Figure 2-1**.

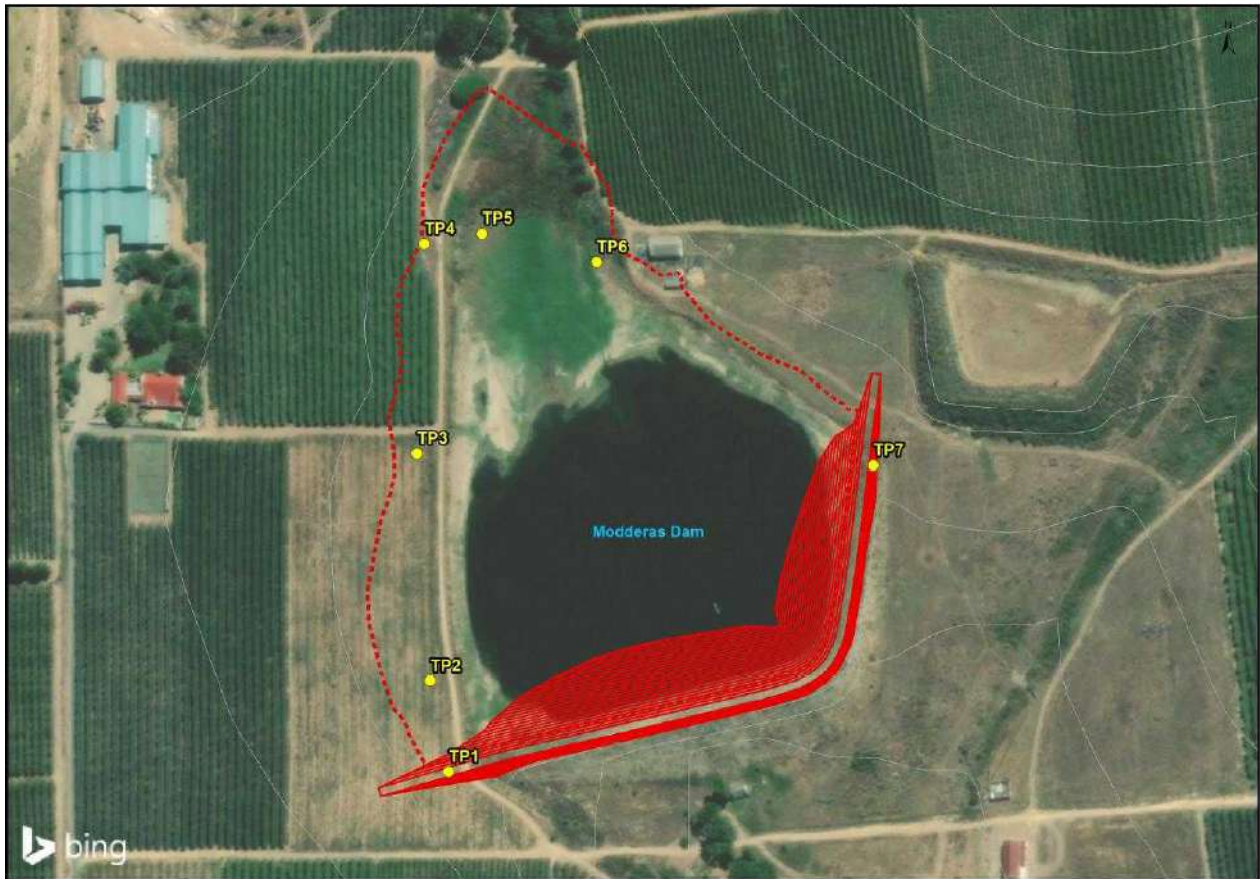
Figure 4-2: Test pit locations

On the 4th of February 2025, seven test pits were excavated at the dam site at the locations shown in **Figure 4-2**. Three samples were collected for laboratory testing.

The soils underlying the dam site generally comprised of a thick layer of fine silty sand, which is underlain by a variable thickness of sandy lean clay, which grades to a weathered shale.

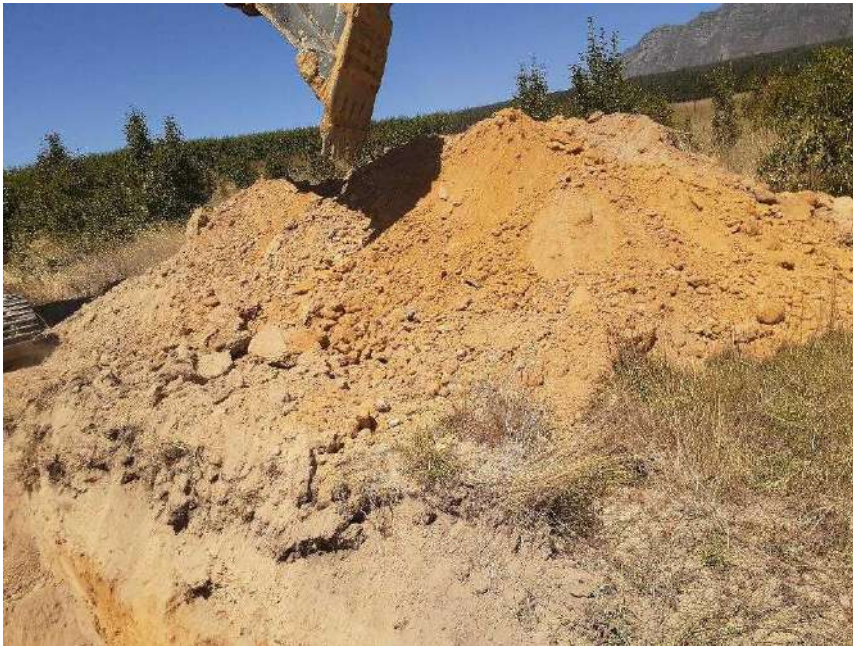
Figure 4-3: Sandy lean clay at TP2

Sandy lean clay, which is typically a good choice of core material, is available in the dam basin in TP2 and TP6. Refer to **Figure 4-3**, **Figure 4-4**.

TP6 results indicate non-dispersivity; while TP2 and TP4's results indicate the material is highly dispersive.

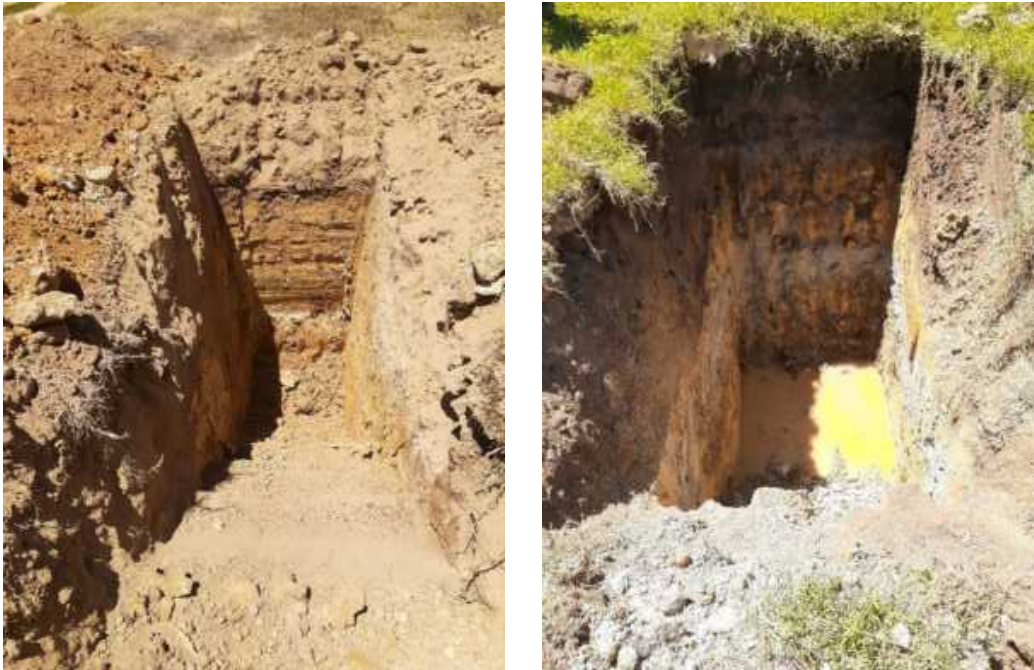
Figure 4-5: Elastic silt at TP4 and TP5 (note ground water in TP5)

Elastic silt material is present in TP4 and TP5. Refer to **Figure 4-5**. The elastic silt material can also be used as a core material when combined with other materials.

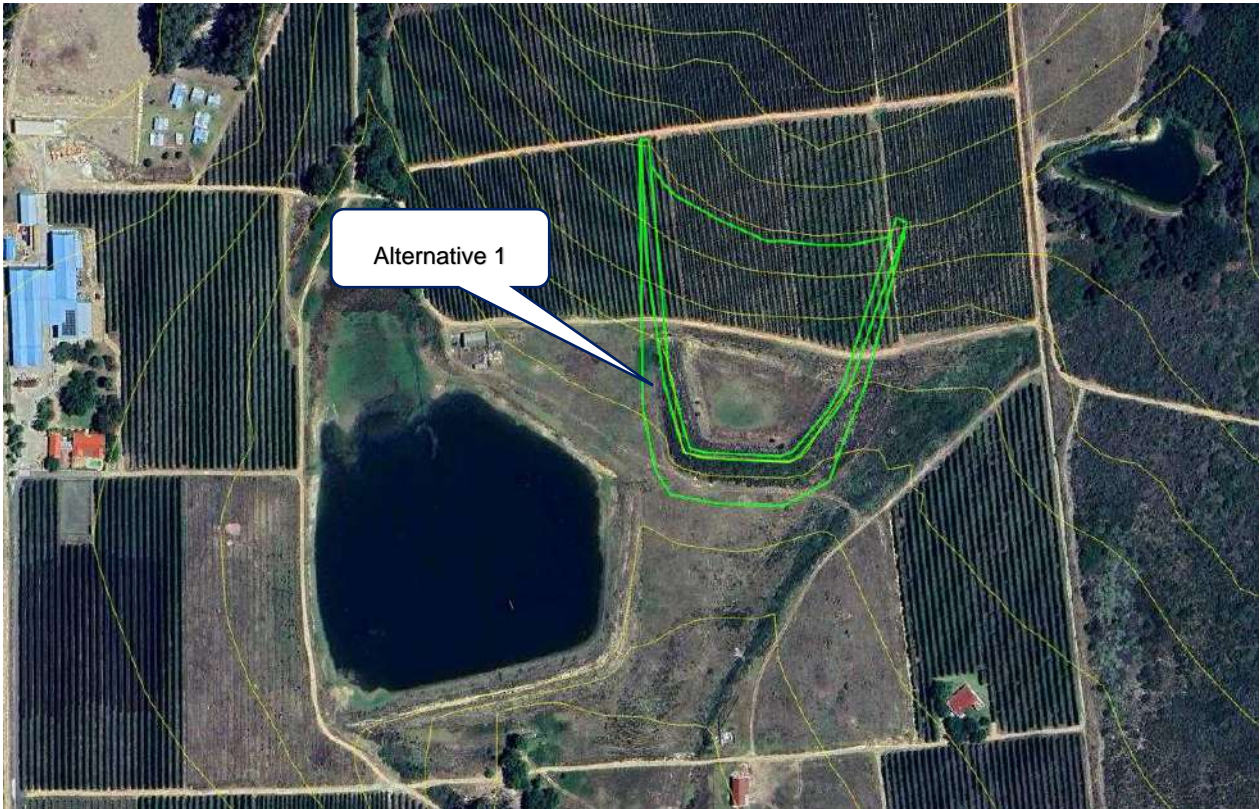
Figure 5-1: Alternative dam site 1

Two alternatives were investigated. The first alternative (Alternative 1) was the repair and enlargement of Dam D2. This alternative would result in the loss of established orchards, which the applicant does not wish to lose. The small catchment area of this alternative would yield very little surface water runoff and thus filling the dam would be heavily reliant on pumping water into the dam. This alternative was considered to be unpractical and uneconomical and therefore it was discarded. Refer to **Figure 5-1**.

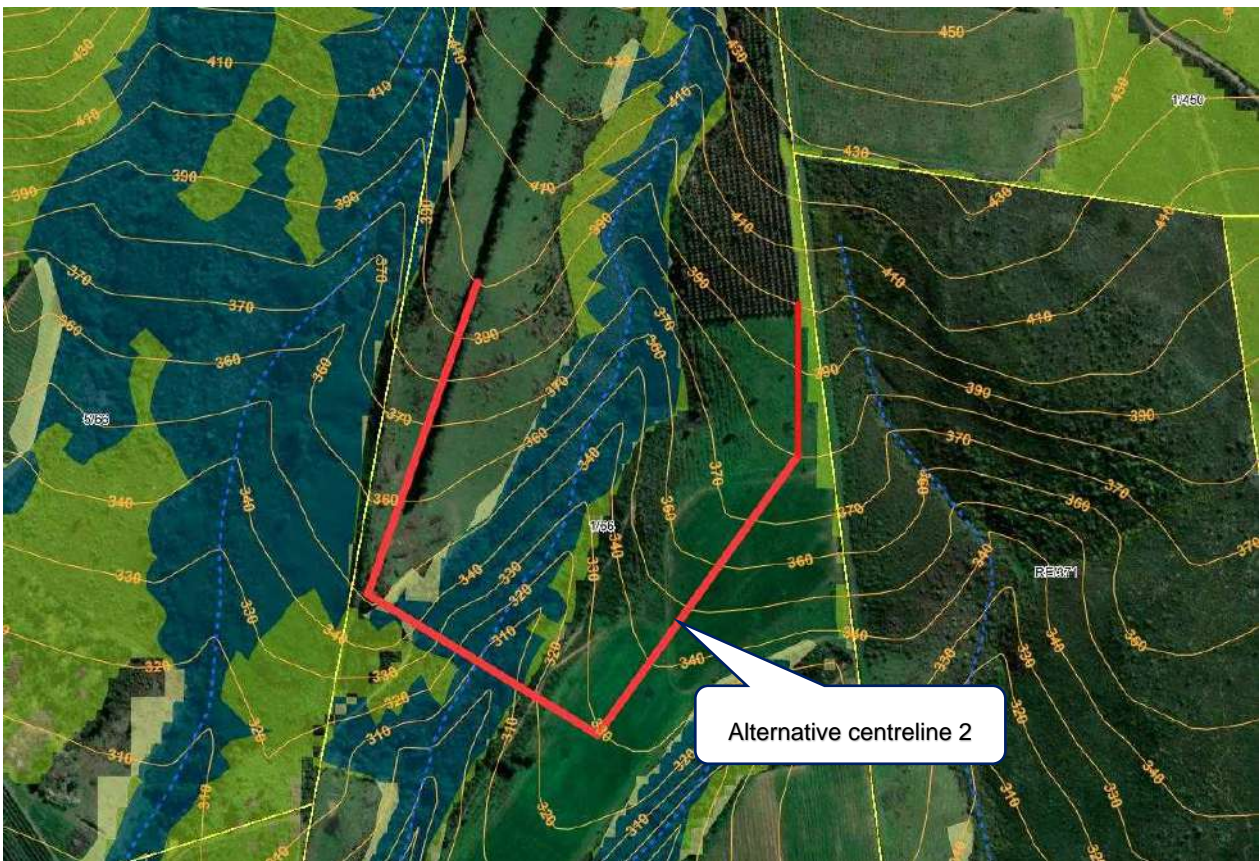
Figure 5-2: Alternative dam site 2

Alternative 2 is located further north and upstream of Modderas Dam. It would be a new on-channel dam. The site is situated within one of the mapped Critical Biodiversity Areas (CBA), which may result in a negative response from the Department of Environmental Affairs and Development Planning (DEA&DP). Past experience indicates that new on-channel dams are not favourable to the DWS for various reasons. Alternative 2 would have a significantly larger impact on the existing stream than the enlargement of the Modderas Dam, as such it was ruled out. Refer to **Figure 5-2**.

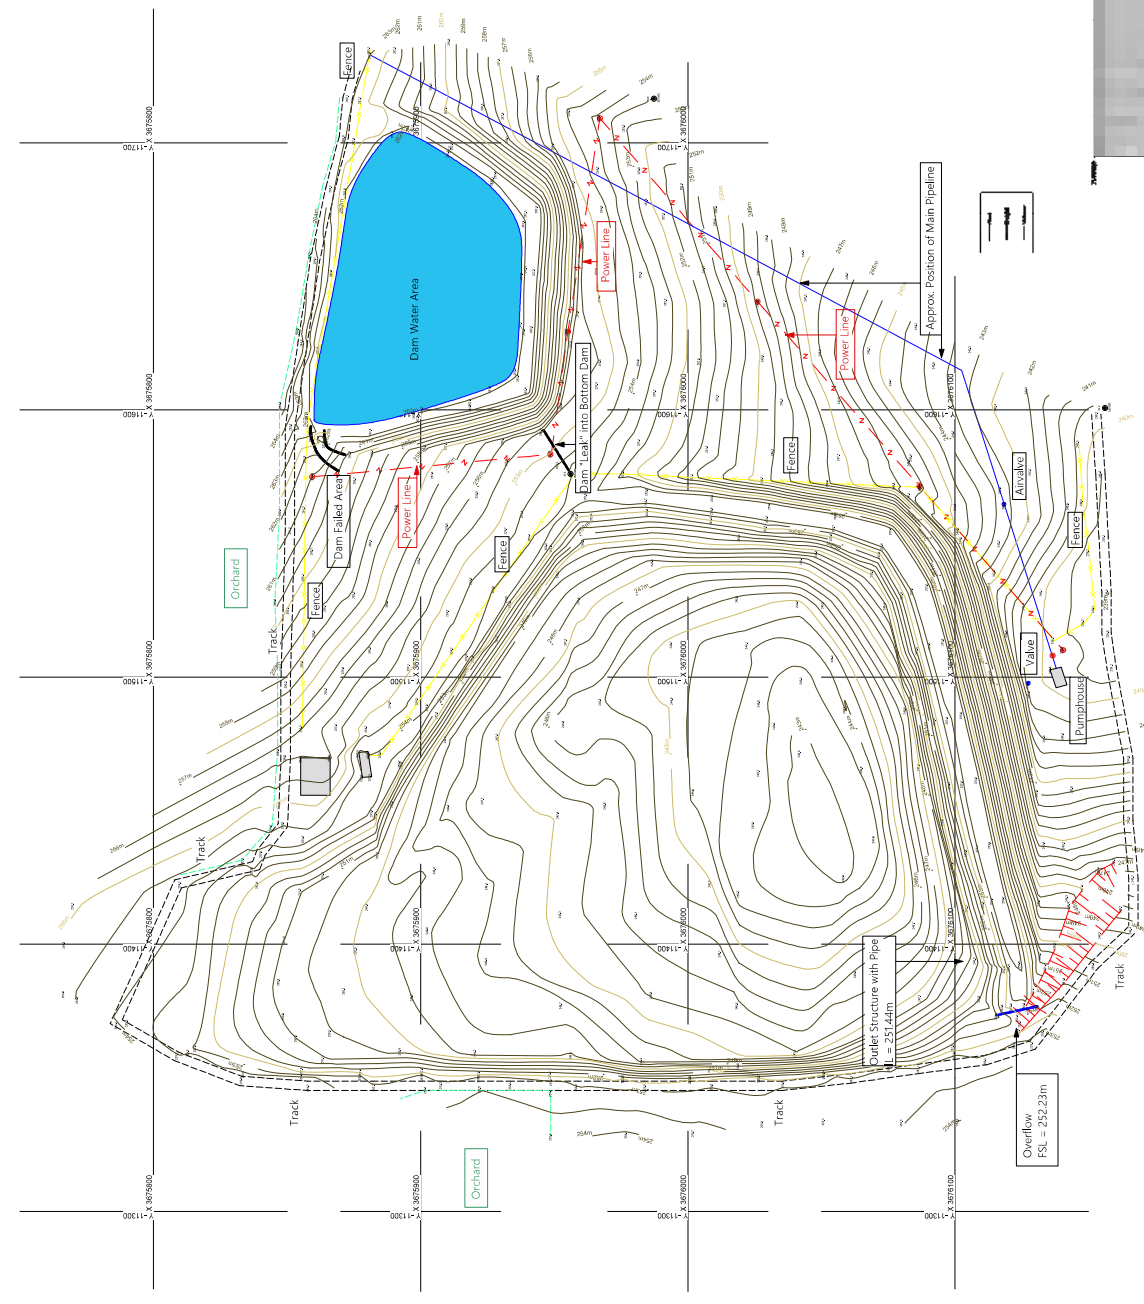
Volume Characteristics Table			
COMPARE	AREA	TOTAL	REMARKS
VALUE	m ²	m ²	
343,0	643,5	50,5	
243,5	2732,9	2689,1	
344,0	4904,5	4600,5	
244,5	2226,9	5996,5	
345,0	4007,8	6950,0	
245,5	13369,7	25998,2	
346,0	13993,7	26418,1	
247,0	18660,7	29053,7	
348,0	19766,2	31104,4	
249,5	22894,8	42825,5	
350,0	25930,3	60311,7	
251,0	28482,3	76804,8	
351,5	31434,3	87638,9	
252,0	34036,9	102396,2	
352,0	36037,9	119956,4	
253,0	38275,2	141256,2	
353,0	40659,8	161382,4	
254,0	43259,7	181197,3	
354,0	43173,8	203040,7	
255,2	459029,6	232455,9

FSL = 253.23

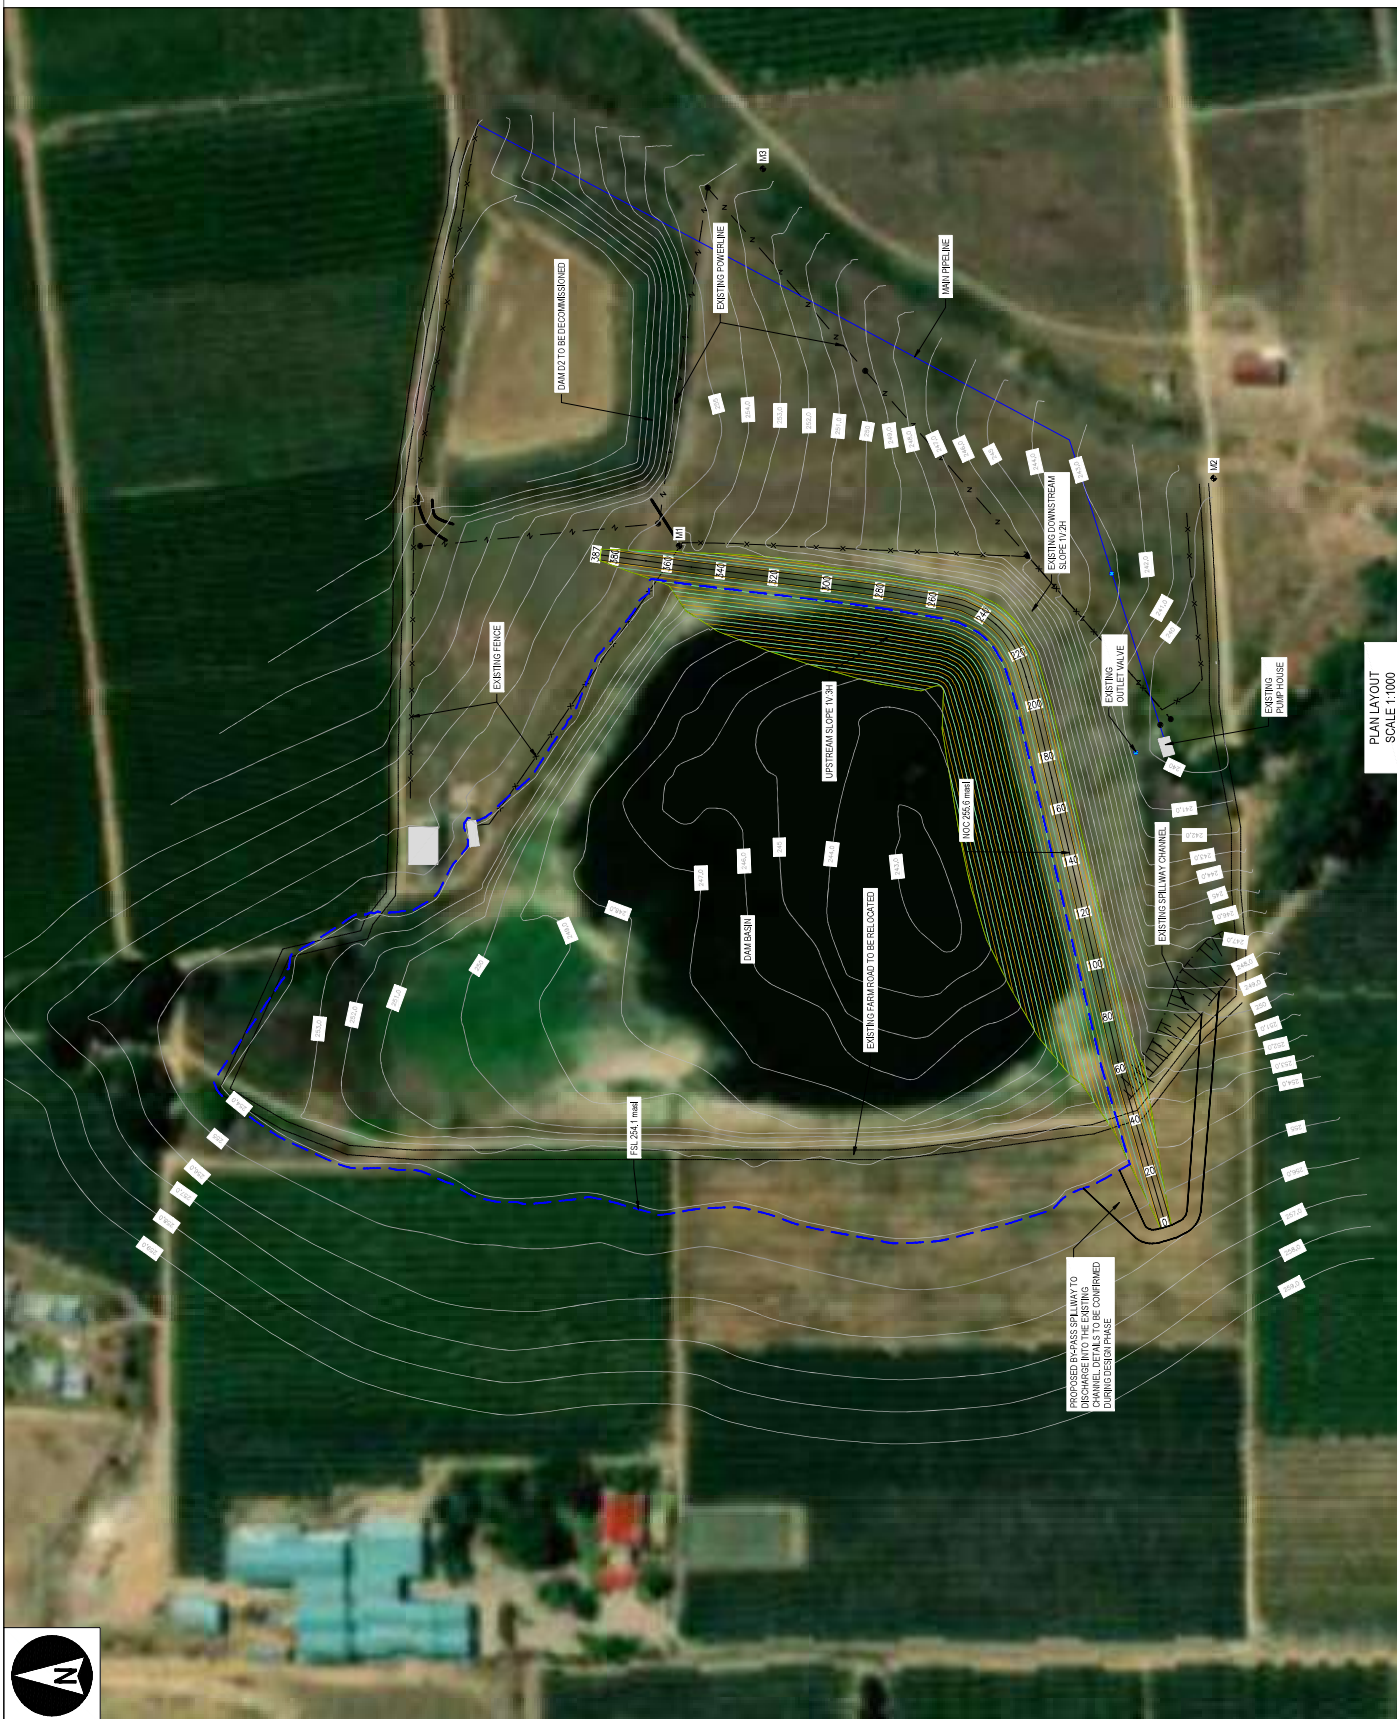
PLAN LAYOUT
SCALE 1:1000

NOTES: MODDERAS DAM - OPTION 1

A layout drawing for the proposed dam Option 1 is included in **Appendix C**.
