ANNEXURE 6: MAINTENANCE MANAGEMENT PLAN

MAINTENANCE AND MANAGEMENT PLAN FOR WATERCOURSE/WETLAND-RELATED MAINTENANCE ACTIVITIES ON PORTION 1 OF THE ROODE ZANDS KLOOF FARM NO. 66, TULBAGH, WESTERN CAPE PROVINCE

Modderasrivier Trust wishes to enlarge Modderas Dam on Portion 1 of the Roode Zands Kloof Farm No. 66. The farm is located approximately 8 km north of Tulbagh in the Western Cape. The purpose of enlarging the existing dam is to store enlistment water that has already been confirmed as existing lawful use. The dam is a Category II dam with a storage capacity of 200 000 m³ and a maximum wall height of 13.8 m.

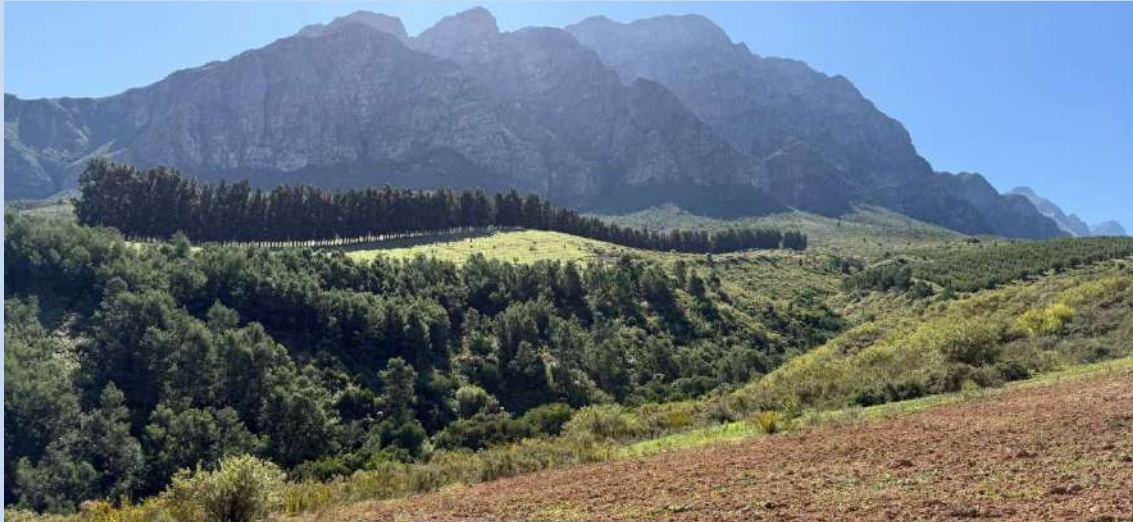
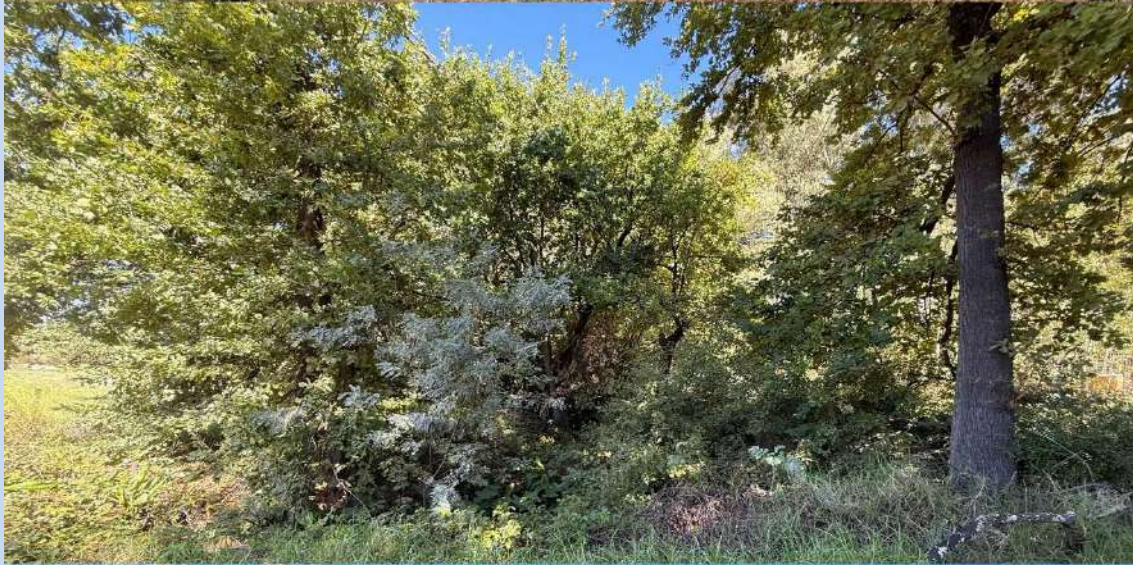
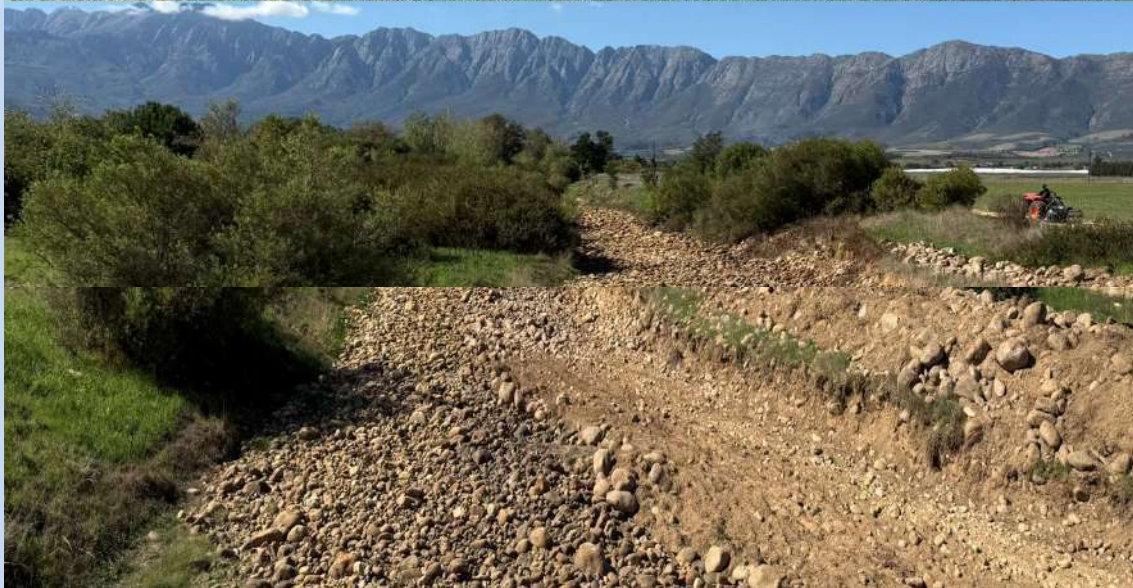
Figure 3. Views of the Modderas Stream upstream (top and centre) and downstream (bottom) of the dam

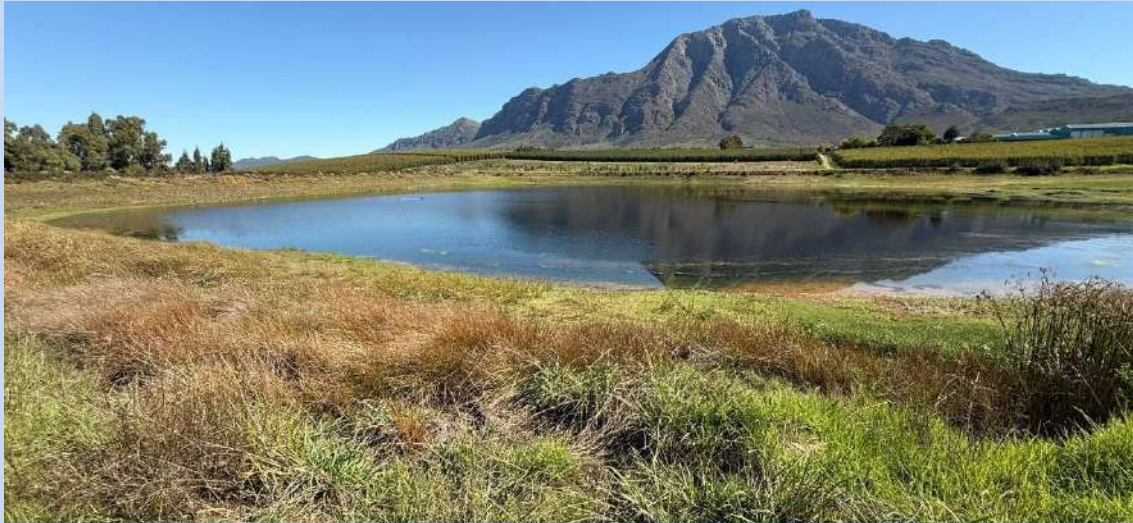
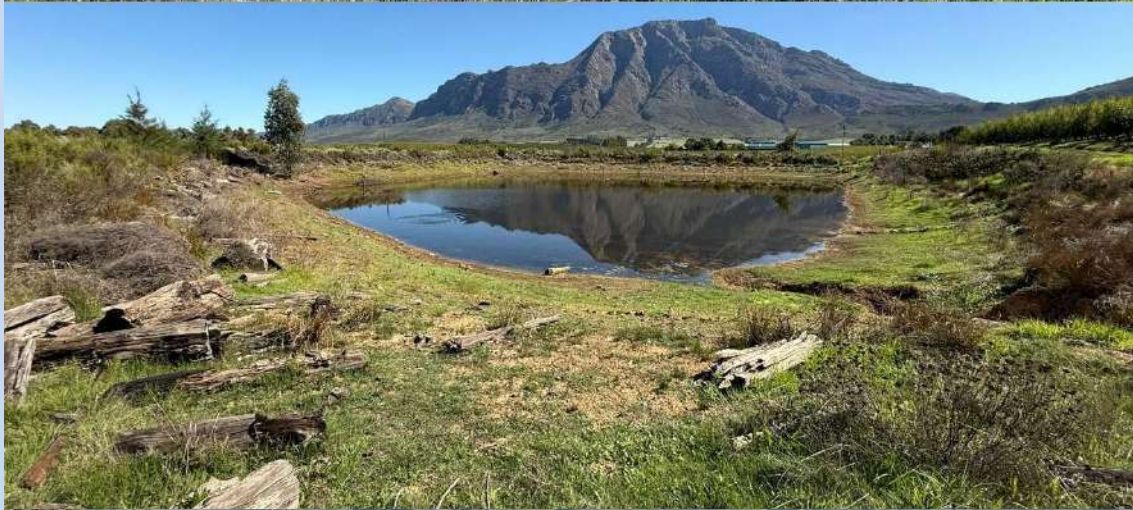
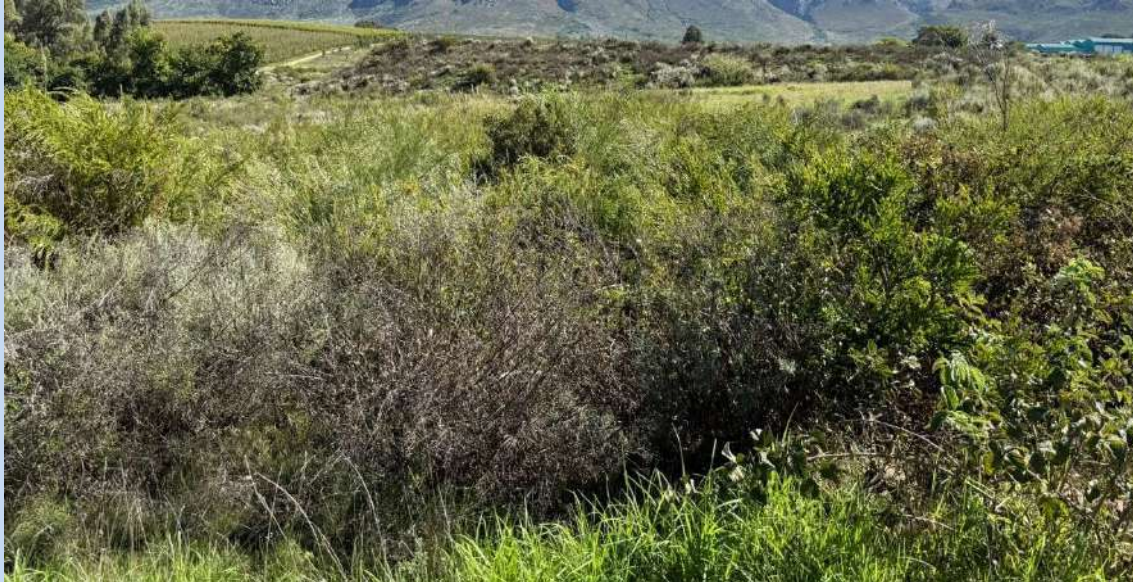
Figure 4. Views of the Modderas Dam (top) and Dam 2 proposed to be decommissioned (middle) as well as the tributary of the Modderas River near Dam 2(bottom)

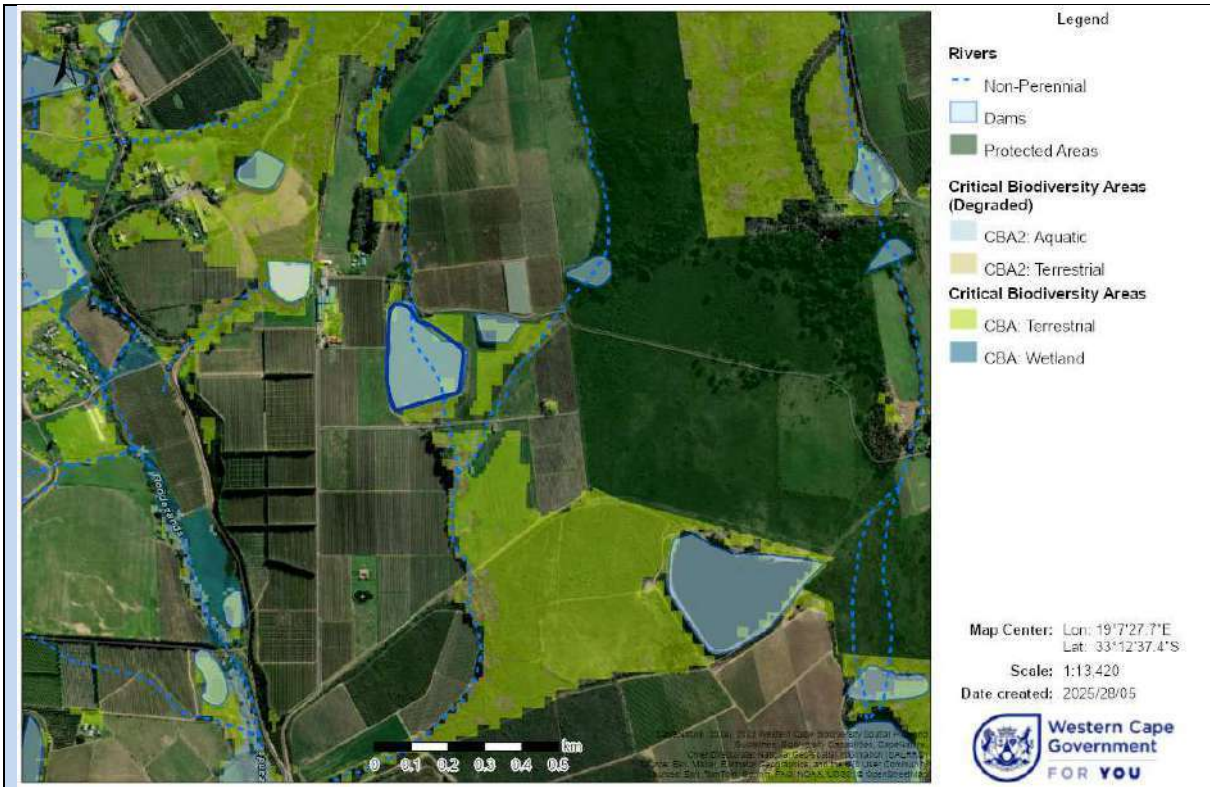
In the 2023 WCBSP (Figure 6), The property lies downslope of the Winterhoek Mountain Catchment Area, a formally protected area. The Welbedacht Nature Reserve is also located about 300m to the east of the dam. Downstream of this, the river has been mapped as a terrestrial CBA.

Figure 6. The 2023 Western Cape Biodiversity Spatial Plan mapping for the site (CapeFarmMapper, 2025).

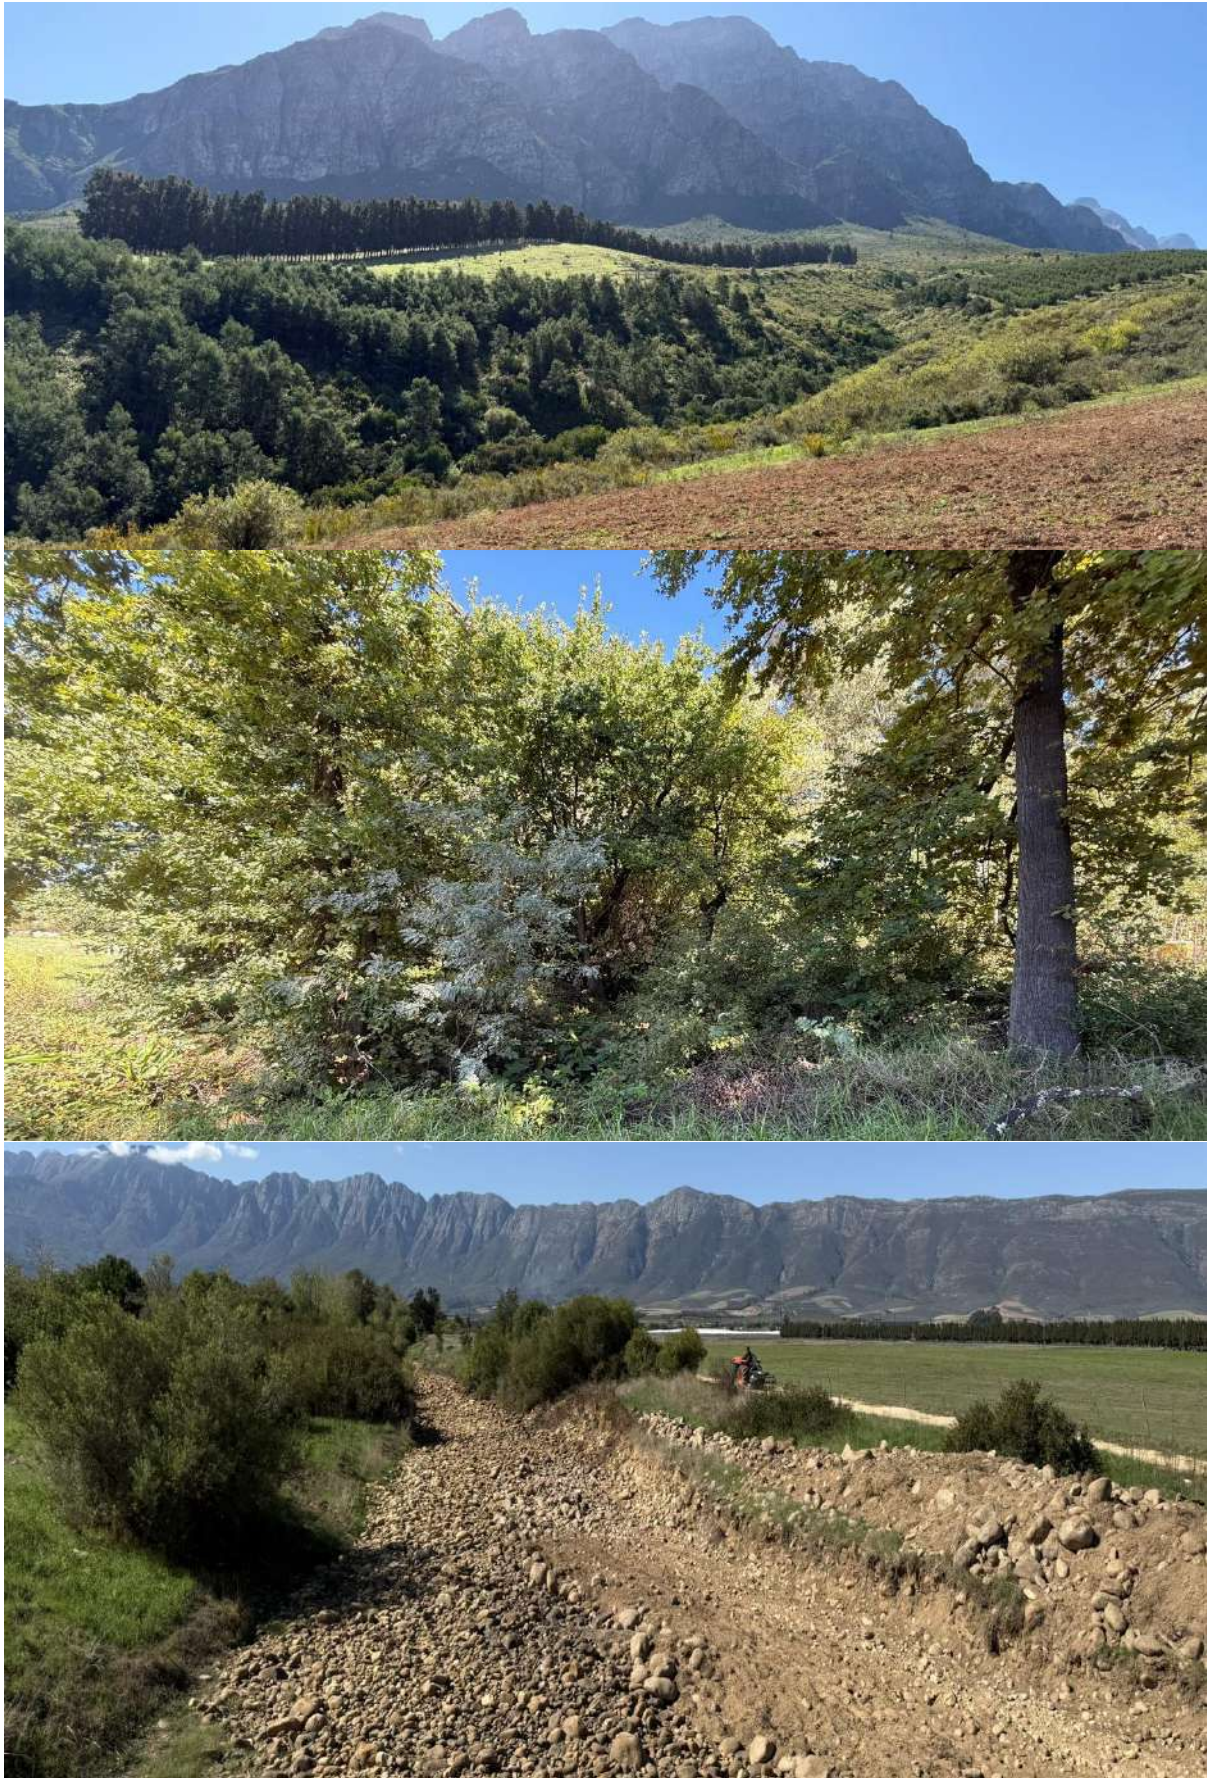
Figure 10. Views of the Modderas Stream upstream (top and centre) and downstream (bottom) of the dam

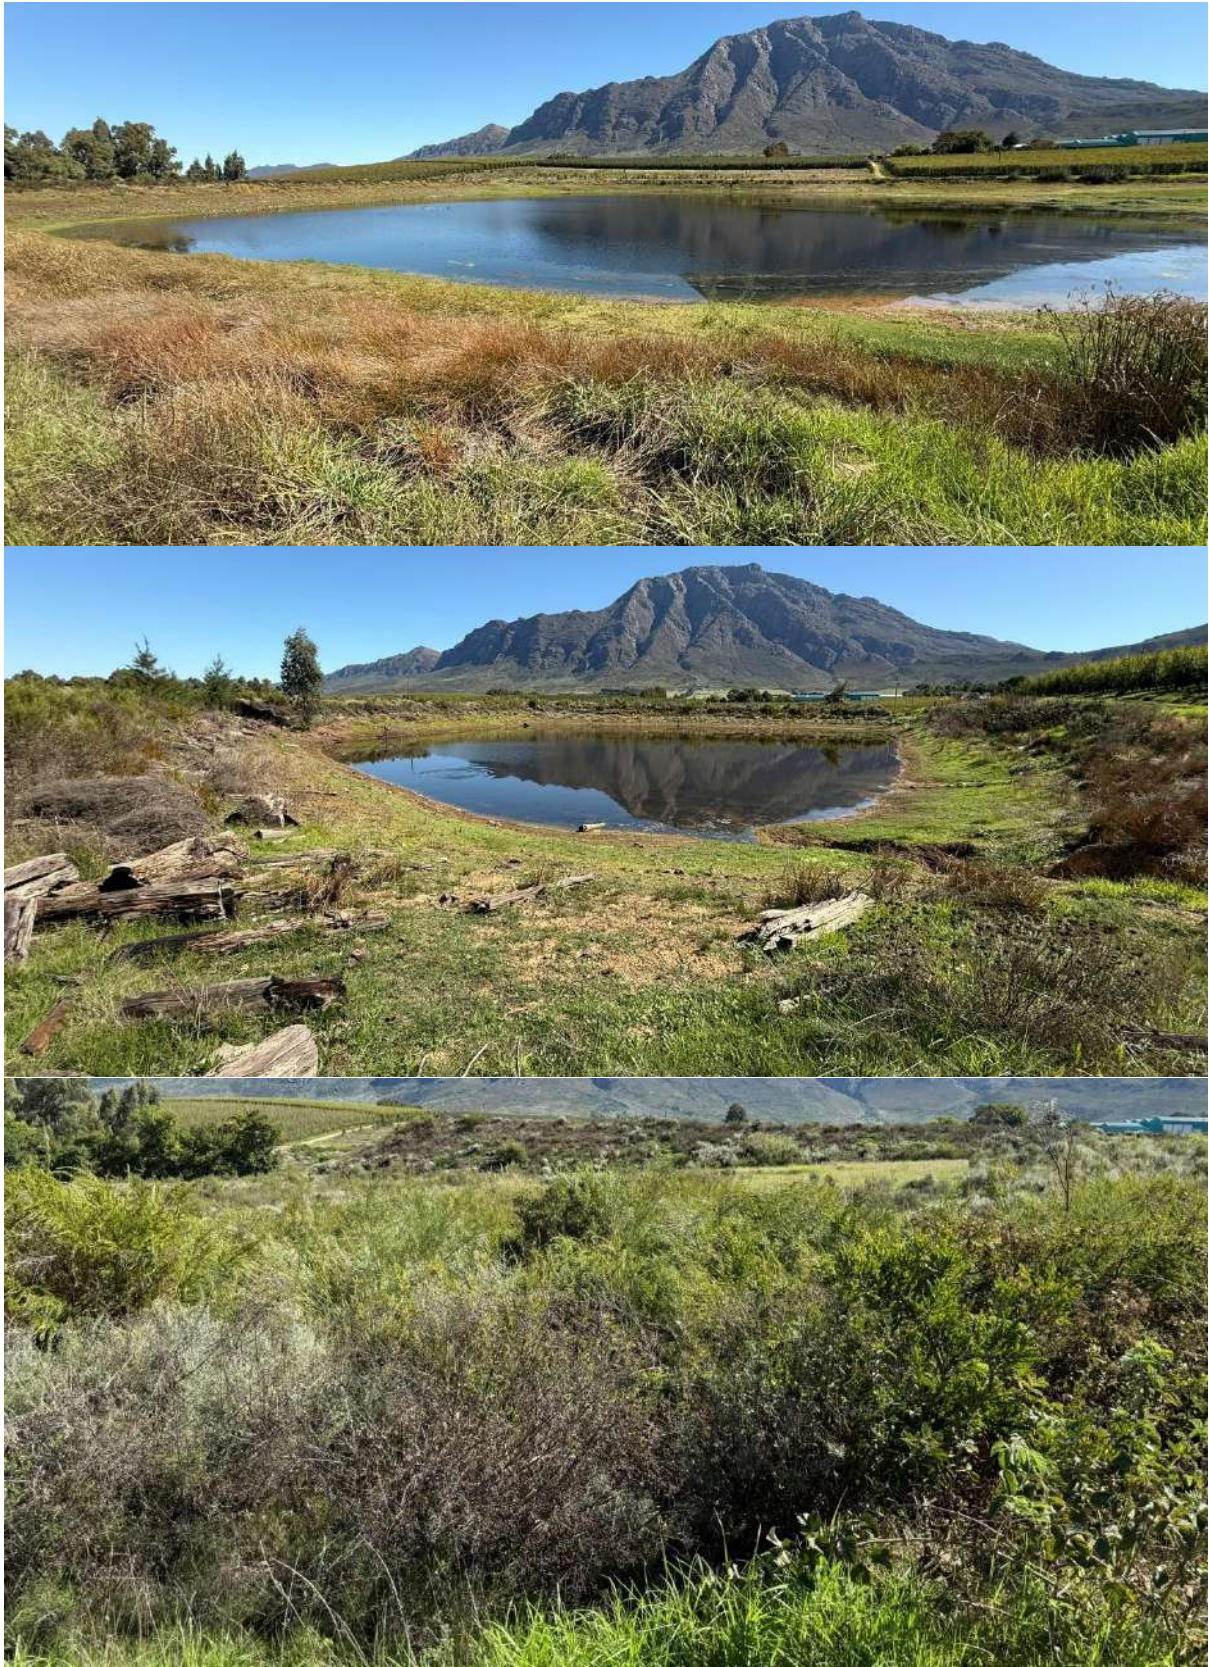
Figure 11. Views of the Modderas Dam (top) and the Alternative Dam 2 (middle) as well as the tributary of the Modderas River near Dam 2(bottom)

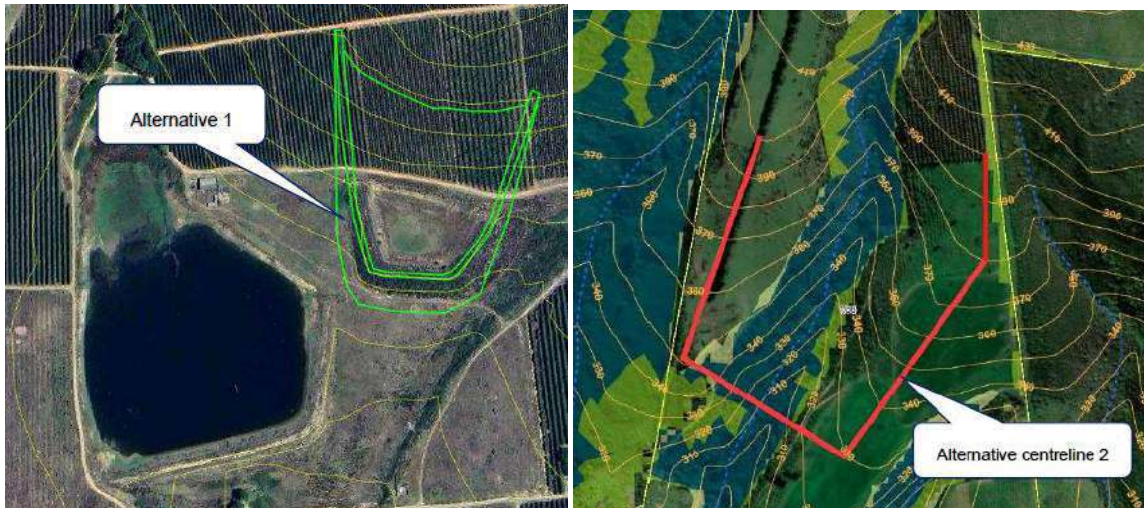
Figure 18. Location of the two dam location alternatives considered.

Various alternatives were investigated that including repair and enlargement of Dam D2, a new instream dam upstream on the Modderas River; and four options for raising of Modderas Dam wall with Option 1 an upstream wall raising being the preferred option from an economic perspective.

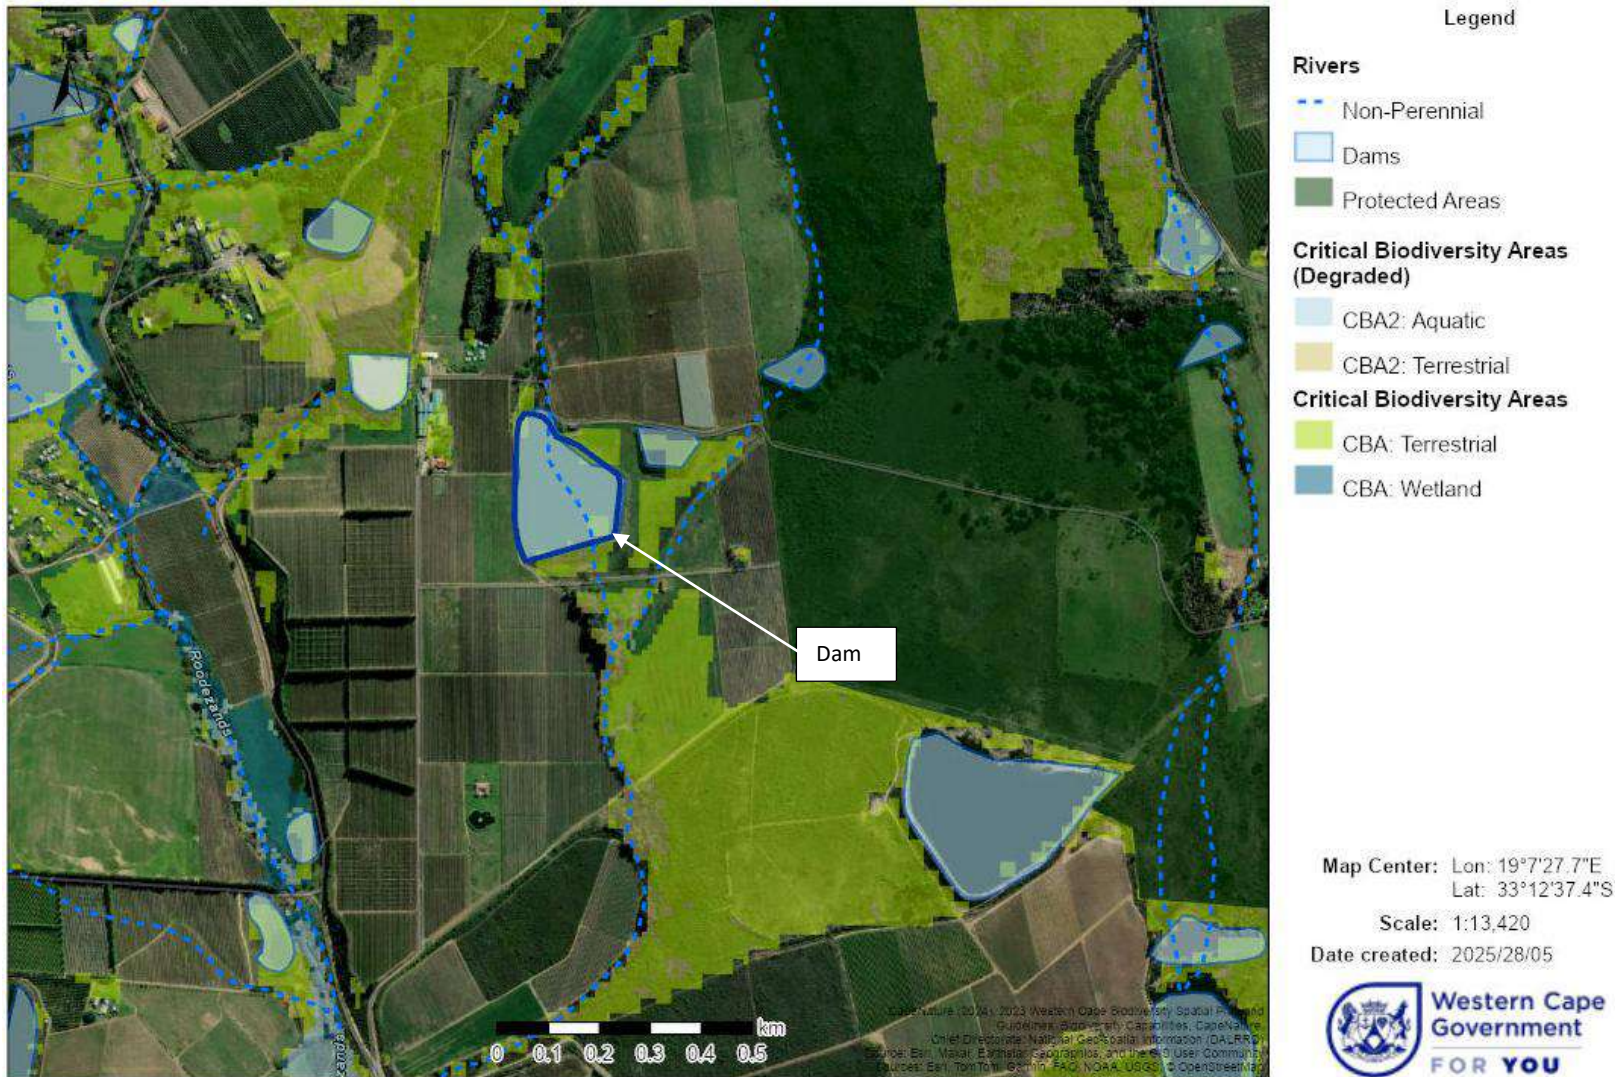
Figure 7. 2023 Western Cape Biodiversity Spatial Plan in the vicinity of the dam (CapeFarmMapper, 2025)

The property lies downslope of the Winterhoek Mountain Catchment Area, a formally protected area. The Welbedacht Nature Reserve is also located about 300m to the east of the dam. Downstream of this, the river has been mapped as a terrestrial CBA (Figure 7).

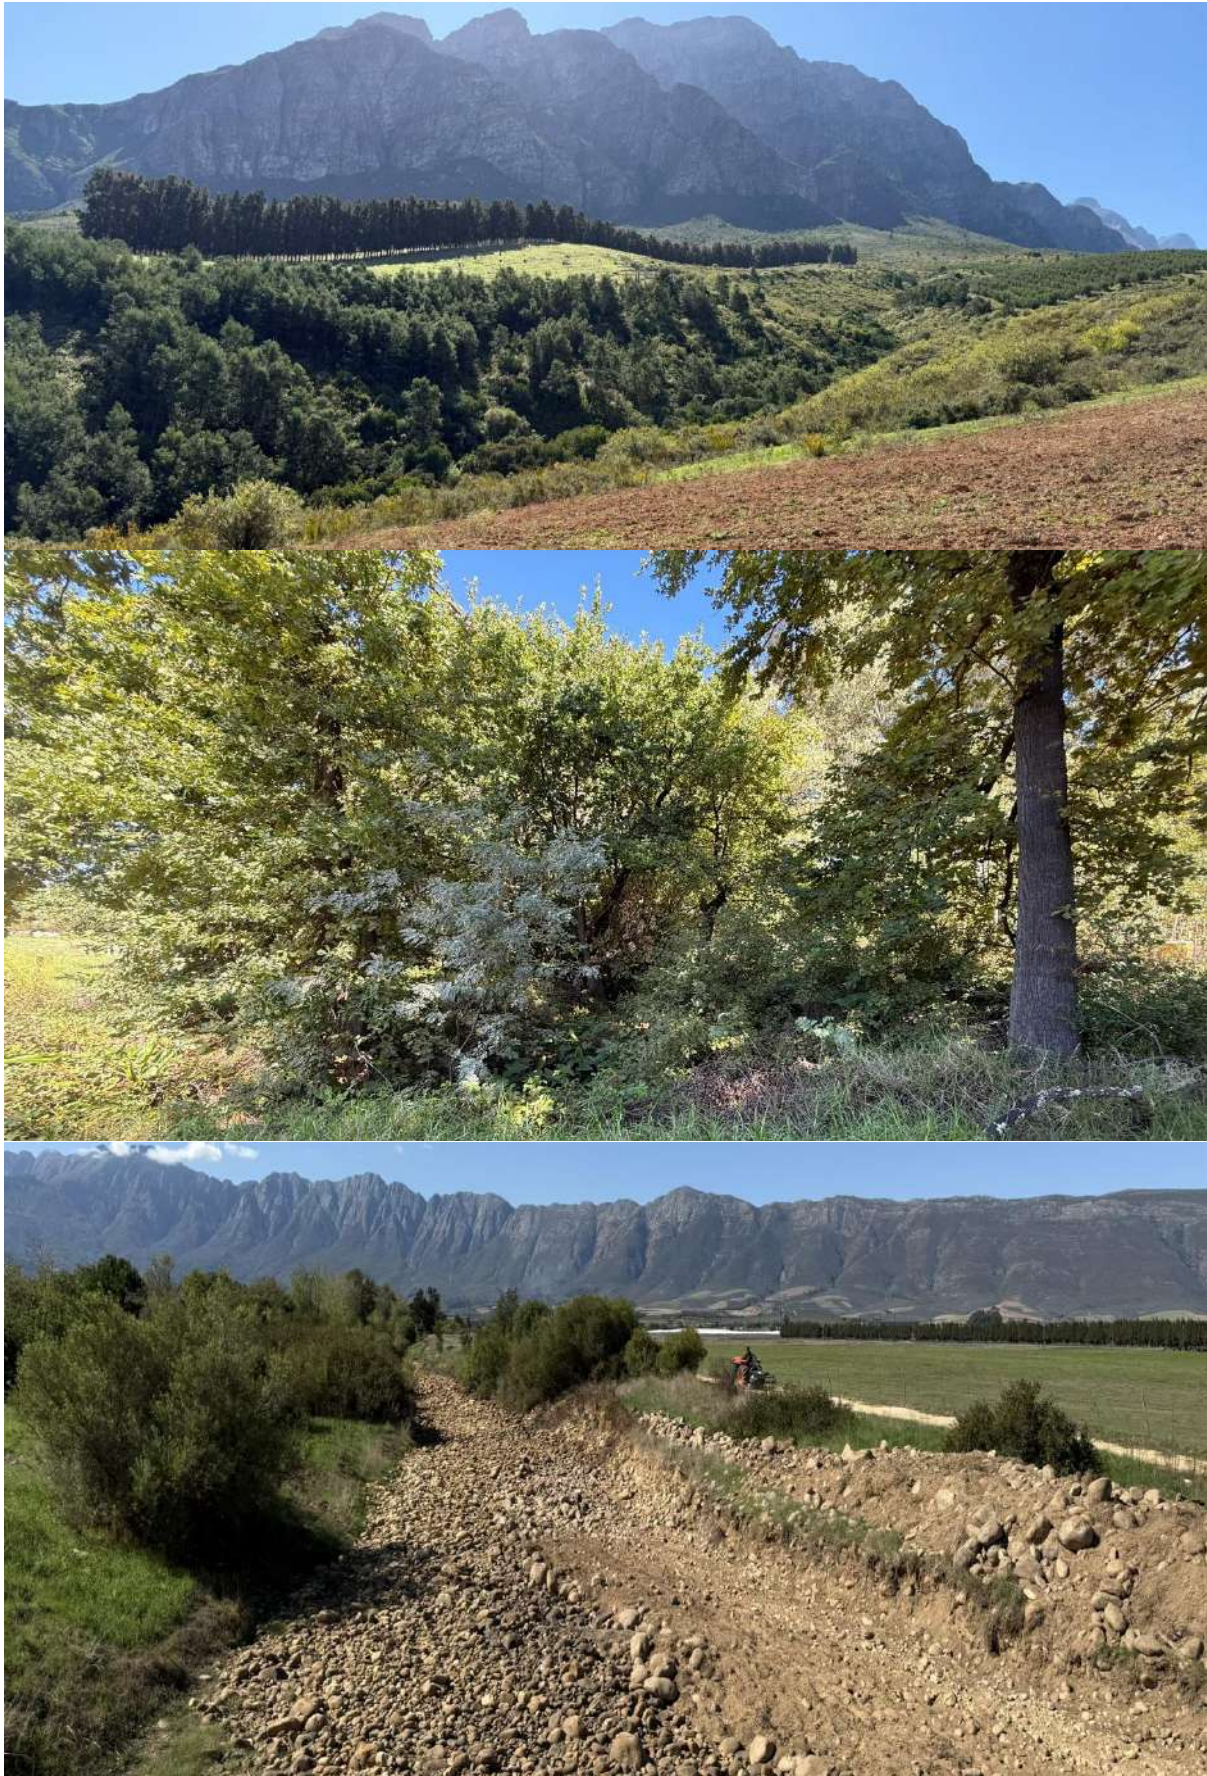
Figure 10. Views of the Modderas Stream upstream (top and centre) and downstream (bottom) of the dam

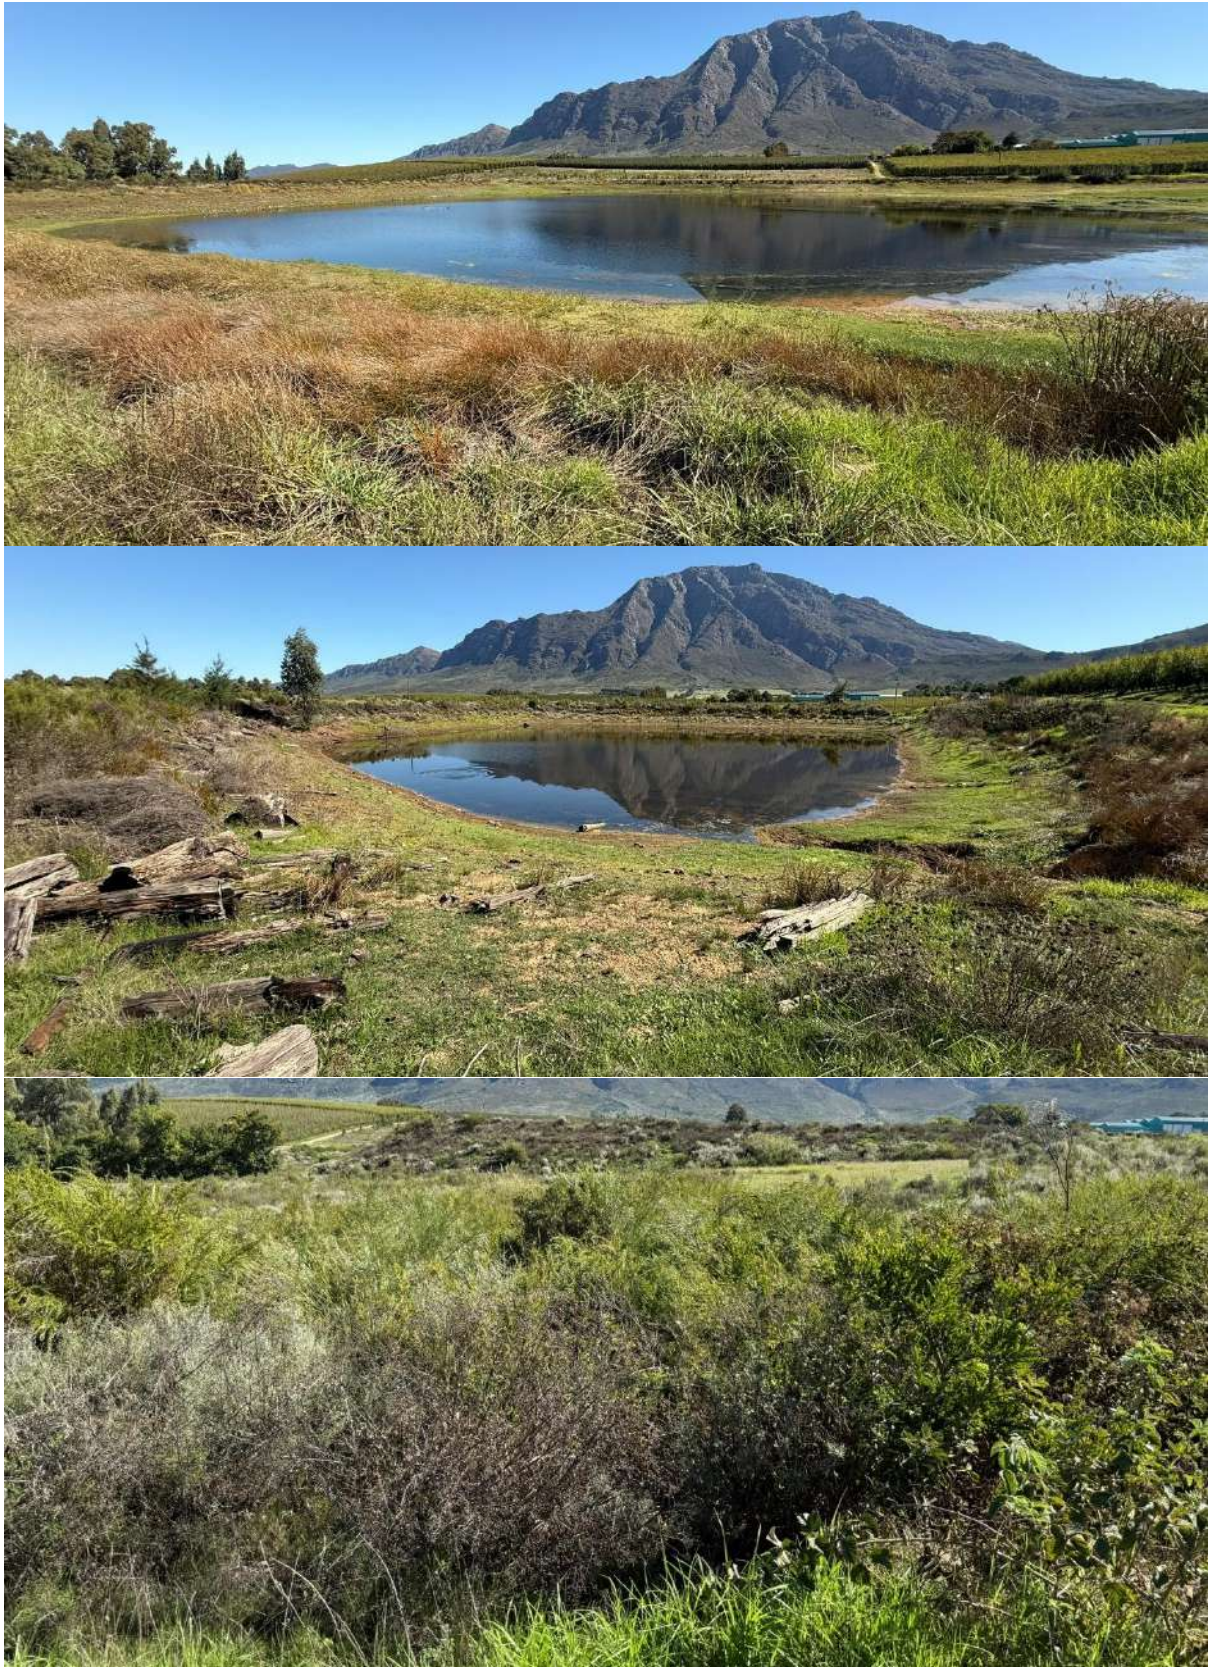
Figure 11. Views of the Modderas Dam (top) and the Alternative Dam 2 (middle) as well as the tributary of the Modderas River near Dam 2(bottom)

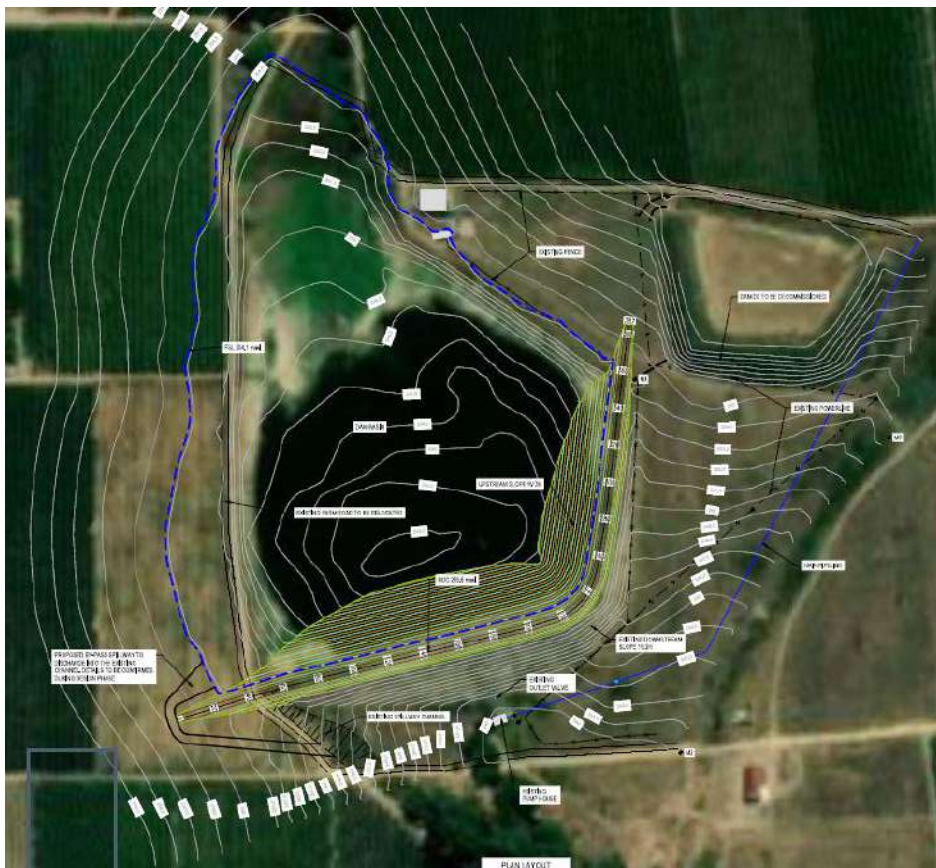
Figure 17. Diagram of the proposed enlargement of the Modderas Dam

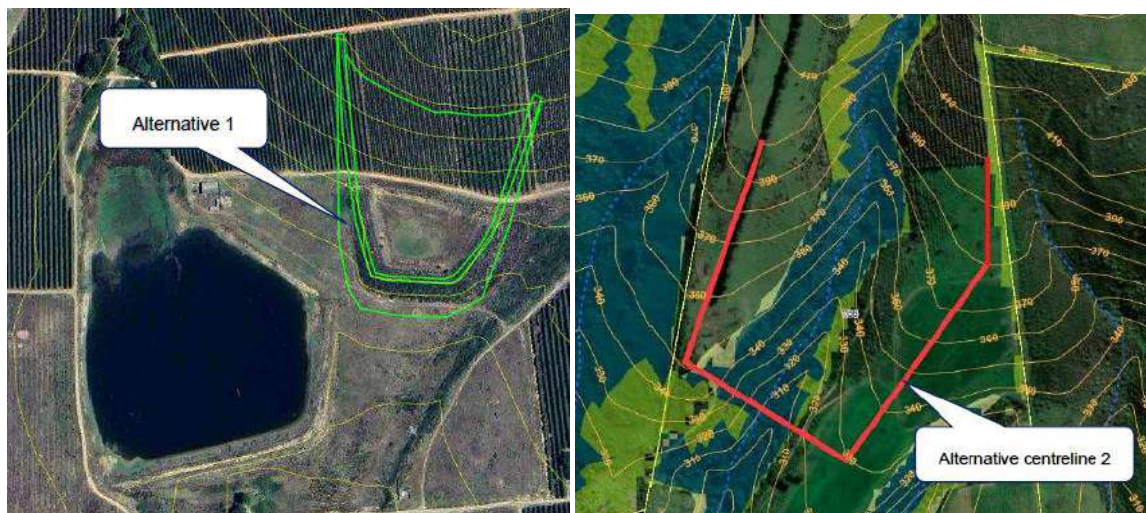
Figure 18. Location of the two dam location alternatives considered.
